**Flood Control Project Maintenance  
Levee Inspections**  
**LMA District Cover Sheet**  
**Spring 2016 Levee Inspection Results**

**Reclamation District No. 0817 Carlin**

**Spring 2016 Levee Inspection Results**

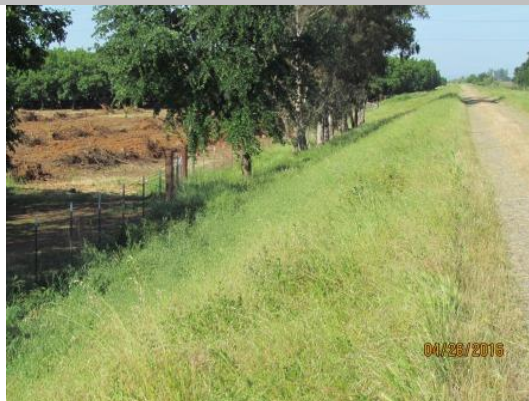
Photo 1 of 1 : SP\_2016\_RD0817\_12\_27\_20160427\_00020.jpg

View of typical vegetation on the landside, looking downstream.

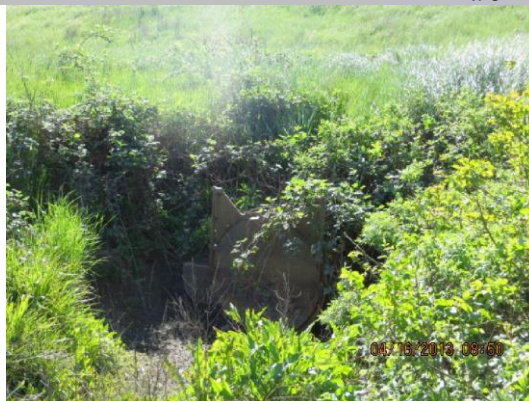
Photo 1 of 2 : UCIP\_SP\_2016\_42685\_19865.jpg

LM Start	0.29	Rating **	M	Issue No.	32
LM End	0.29	Issue Type +	En	Location *	WS
Category	Supplemental			GPS Latitude/Longitude	
				Start	End
Item	DWR UCIP Field Study			38.987813 °	38.987813 °
				-121.502963 °	-121.502963 °
DWR ID					
Comment Code					
Inspector Comment					
FS_ID:42685 DS_ID:18985 EP_NO: N/A Repair Type: Non-Urgent Crossing Status: Found UCIP Comments: Dense vegetation on waterward and landward slopes limit visual inspection of potential leaks along pipe alignment. Recommend having owner clear vegetation along slopes. FIELD_STRUCT_DESC: 48-inch corrugated metal drainpipe through levee, 23.3 feet below the crown. Flap gate on waterward end. FS Date: 4/16/2013

WS- pipe, flap gate in dense vegetation on berm

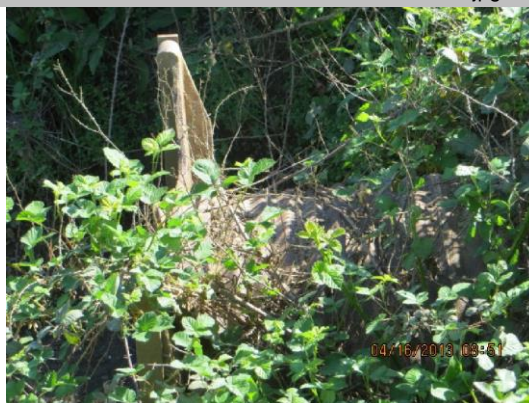
Photo 2 of 2 : UCIP\_SP\_2016\_42685\_19864.jpg

WS- CM pipe and flap gate

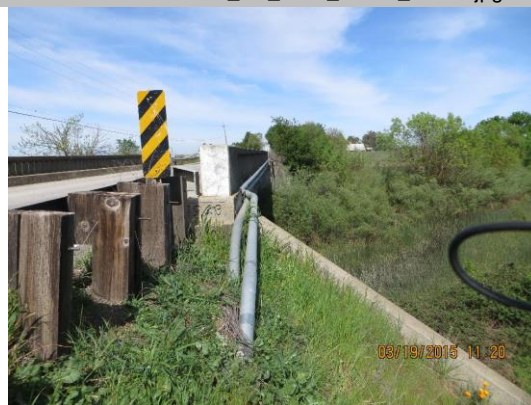
Photo 1 of 2 : UCIP\_SP\_2016\_44084\_73565.jpg

LM Start	1.13	Rating **	M	Issue No.	46
LM End	1.13	Issue Type +	En	Location *	WS
Category	Supplemental			GPS Latitude/Longitude	
				Start	End
Item	DWR UCIP Field Study			38.995667 °	38.995667 °
				-121.490981 °	-121.490981 °
DWR ID					
Comment Code					
Inspector Comment					
FS_ID:44084 DS_ID:25088 EP_NO: N/A Repair Type: Non-Urgent Crossing Status: Found UCIP Comments: No permit identified for this crossing. FIELD_STRUCT_DESC: 4-inch steel communication conduit through the levee, 4 feet below levee crown. FS Date: 3/19/2015

Communication conduit visible on upstream side of bridge.

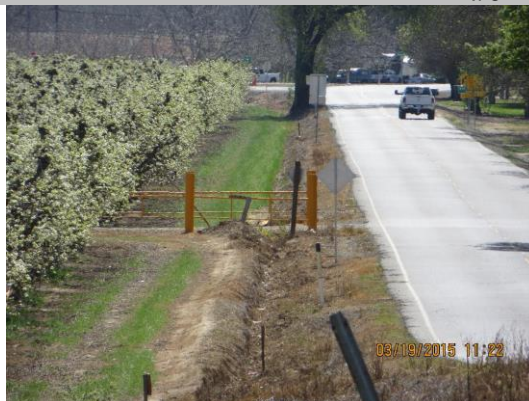
Photo 2 of 2 : UCIP\_SP\_2016\_44084\_73564.jpg

Fiberoptic line markers along roadway to south of bridge.

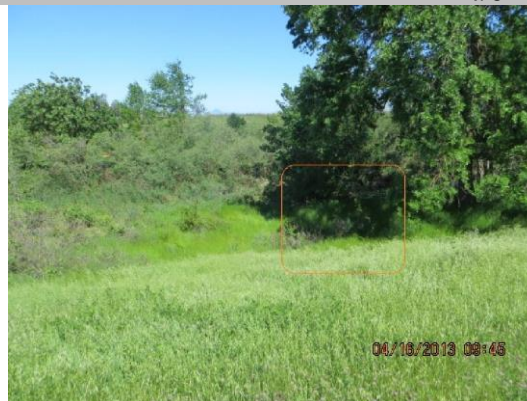
Photo 1 of 2 : UCIP\_SP\_2016\_41153\_19882.jpg

Comment Code					
Inspector Comment					
FS_ID:41153 DS_ID:18987 EP_NO: N/A Repair Type: Non-Urgent Crossing Status: Found UCIP Comments: Damaged slide gate on WS of the levee. Need to contact owner to determine status of crossing. If crossing is no longer in use owner will need to contact CVFPB to comply with Title 23. Dense vegetation on waterward and landward slopes limit visual inspection of potential leaks along pipe alignment. Recommend having owner clear vegetation along slopes. FIELD_STRUCT_DESC: *ABANDONED* 18-inch corrugated metal drainpipe through levee, 14.9 feet below the crown. Slide gate on the waterward end. O&M Manual Sac 146, November 1962. FS Date: 4/16/2013

WS- overview of WS area

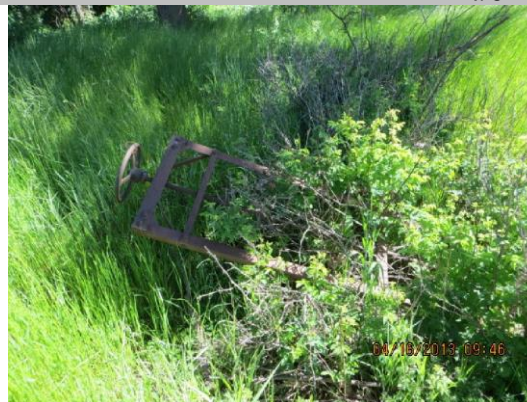
Photo 2 of 2 : UCIP\_SP\_2016\_41153\_19881.jpg

WS- closer look at damaged slide gate on WS

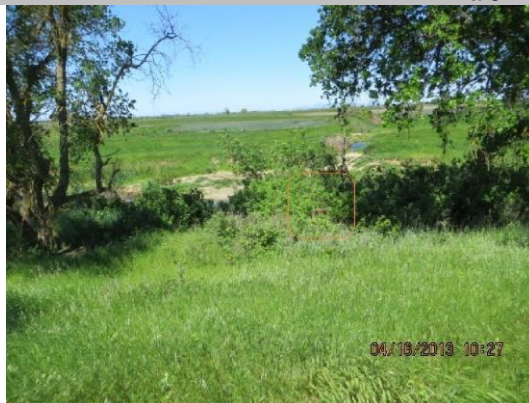
Photo 1 of 2 : UCIP\_SP\_2016\_41157\_19892.jpg

FS\_ID:41157  
DS\_ID:18988  
EP\_NO: N/A  
Repair Type: Non-Urgent  
Crossing Status: Found  
UCIP Comments: A buried slide gate on WS of the levee. Need to contact owner to determine status of crossing. If crossing is no longer in use owner will need to contact CVFPB to comply with Title 23. Dense vegetation on waterward and landward slopes limit visual inspection of potential leaks along pipe alignment. Recommend having owner clear vegetation along slopes.  
FIELD\_STRUCT\_DESC: \*ABANDONED\* 18-inch corrugated metal drainpipe through the levee, 14.9 feet below the crown. Slide gate on the waterward end. O&M Manual Sac 146, November 1962.  
FS Date: 4/16/2013

WS- overview of WS berm

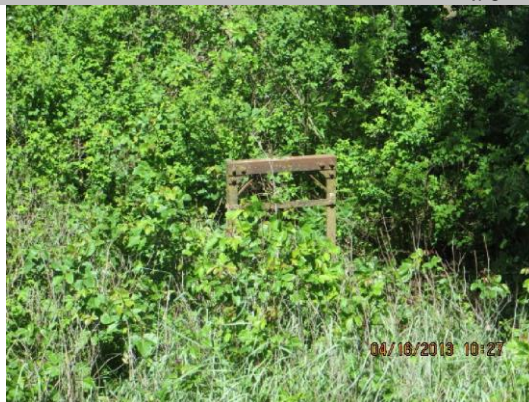
Photo 2 of 2 : UCIP\_SP\_2016\_41157\_19891.jpg

WS- slide gate

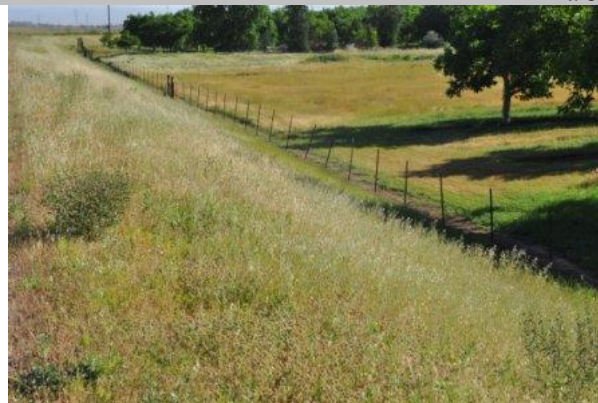
Photo 1 of 1 : SP\_2016\_RD0817\_12\_8\_20160307\_00001.jpg

Wire fence at L/S levee toe.

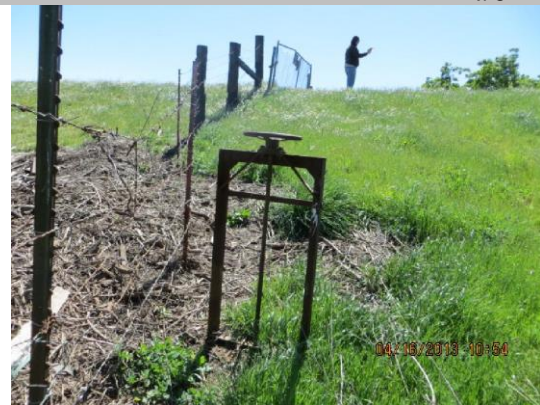
Photo 1 of 1 : UCIP\_SP\_2016\_41156\_19895.jpg

Comment Code					
Inspector Comment					
FS_ID:41156 DS_ID:18989 EP_NO: N/A Repair Type: Non-Urgent Crossing Status: Indicator Found UCIP Comments: A burried slide gate found on WS. Need to contact owner to determine status of crossing. If crossing is no longer in use owner will need to contact CVFPB to comply with Title 23. Dense vegetation on waterward and landward slopes limit visual inspection of potential leaks along pipe alignment. Recommend having owner clear vegetation along slopes. FIELD_STRUCT_DESC: 8-inch corrugated metal drainpipe through levee, 11.7 feet below the crown. Slide gate on the waterward end. O&M Manual Sac 146, November 1962. (Permit 16193, 1994, was issued for the removal of this crossing, but slidegate appears to remain on WS toe. FS Date: 4/16/2013

WS- slide gate on levee toe.

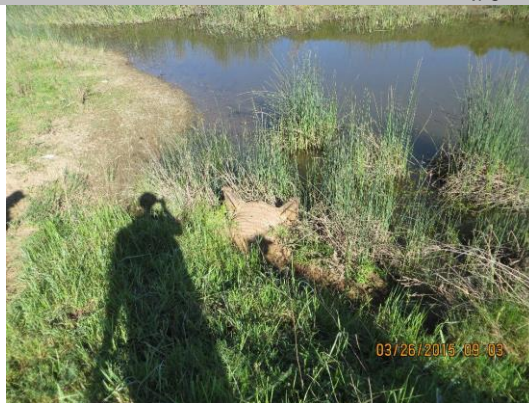
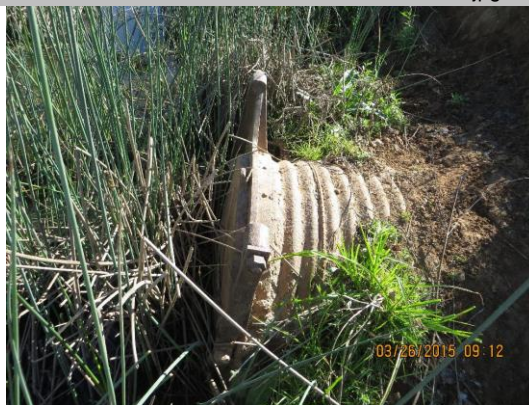
LM Start	2.96	Rating **	M	Issue No.	48
LM End	2.96	Issue Type +	En	Location *	LS
Category	Supplemental			GPS Latitude/Longitude	
				Start	End
Item	DWR UCIP Field Study			39.012552 °	39.012552 °
				-121.466538 °	-121.466538 °
DWR ID					
Comment Code					
Inspector Comment					
FS_ID:43946 DS_ID:18992 EP_NO: N/A Repair Type: Non-Urgent Crossing Status: Found UCIP Comments: Flapgate in closed position, but blocked from operation on WS toe. Pipe appears abandoned and should be verified as having been done so properly. FIELD_STRUCT_DESC: 36-inch corrugated metal drainpipe through the levee, 13.7-feet below the crown. Flap gate on the waterward end. O&M Manual Sac 146, November 1962. FS Date: 3/26/2015

Pipe and flapgate visible on WS toe.

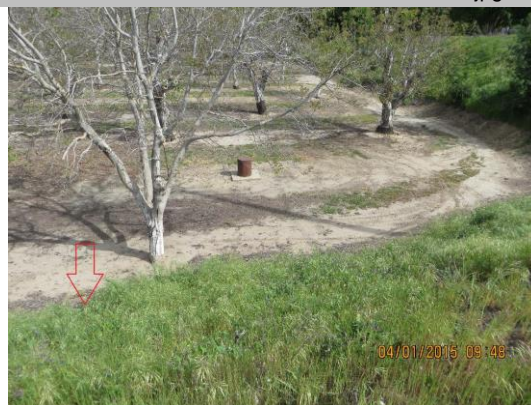
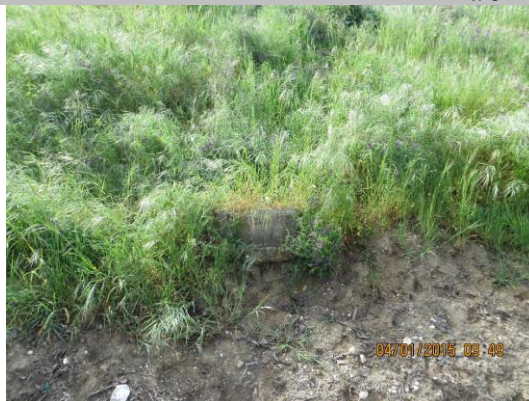
Concrete standpipe visible on lower slope of LS toe.

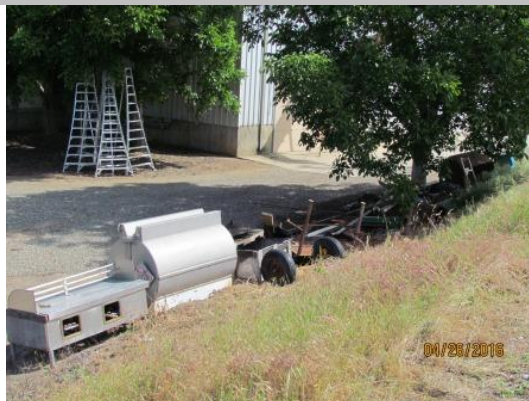
Photo 1 of 1 : SP\_2016\_RD0817\_13\_3\_20160427\_00019.jpg

Photo of equipment encroaching onto the landside toe.

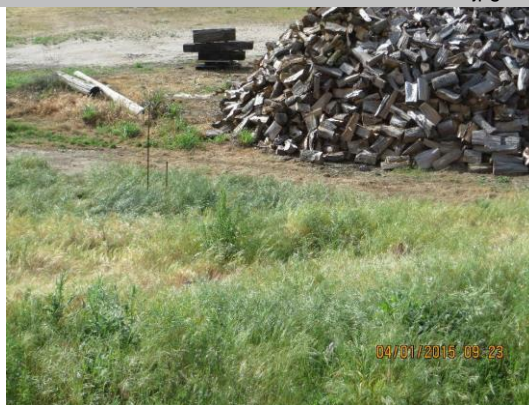
Photo 1 of 2 : UCIP\_SP\_2016\_46182\_74559.jpg

LM Start	2.05	Rating **	M	Issue No.	20
LM End	2.05	Issue Type +	En	Location *	LS
Category	Supplemental			GPS Latitude/Longitude	
				Start	End
Item	DWR UCIP Field Study			38.989212 °	38.989212 °
				-121.469137 °	-121.469137 °
DWR ID					
Comment Code					
Inspector Comment					
FS_ID:46182 DS_ID:25095 EP_NO: N/A Repair Type: Non-Urgent Crossing Status: Found UCIP Comments: Need to determine permit for crossing. FIELD_STRUCT_DESC: 2-inch galvanized iron waterline through the levee at an unknown depth below the crown. Hose bib at WS toe. Possible connection at building corner on LS. FS Date: 4/1/2015

Pipe and hose bib visible in tall grass at WS toe.

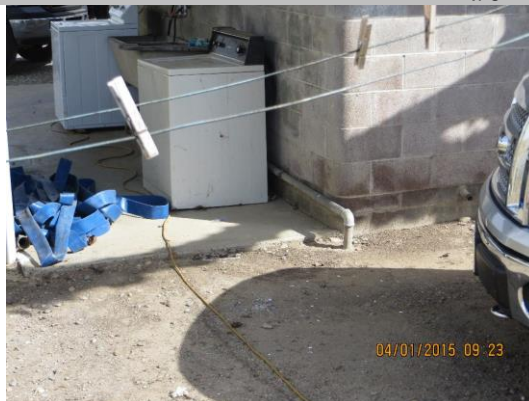
Photo 2 of 2 : UCIP\_SP\_2016\_46182\_74560.jpg

Possible source on LS at building corner.

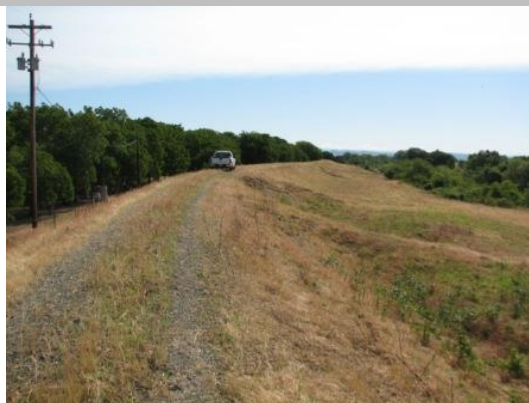
Photo 1 of 1 : SP\_2016\_RD0817\_13\_10\_20160307\_00004.jpg

LM Start	2.08	Rating **	U	Issue No.	10
LM End	3.18	Issue Type +	Ob	Location *	N/A
Category	Earthen Levee			GPS Latitude/Longitude	
				Start	End
Item	Slope Stability			38.989338 °	38.994124 °
				-121.468640 °	-121.449448 °
DWR ID	DWR_RD0817_02_s_2012_10				
Comment Code					
S1 : Repair slope instability.					
Inspector Comment					
The levee is oversteepend at this location. The LMA states that it has always been like this and the USACE did not finish constructing the levee here.

Levee mile 2.08, this photo shows the slope is less than required, this is the downstream limit of the site, this is the waterside slope.

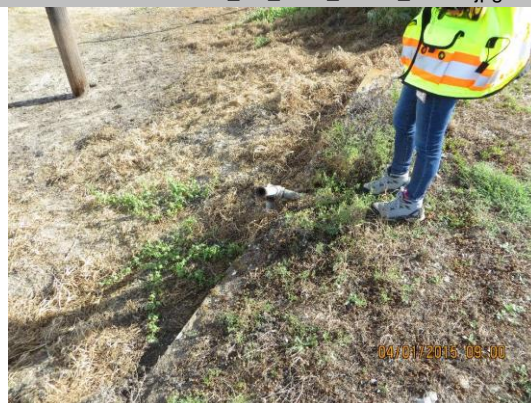
Photo 1 of 2 : UCIP\_SP\_2016\_44105\_73586.jpg

Pipe visible on LS shoulder.

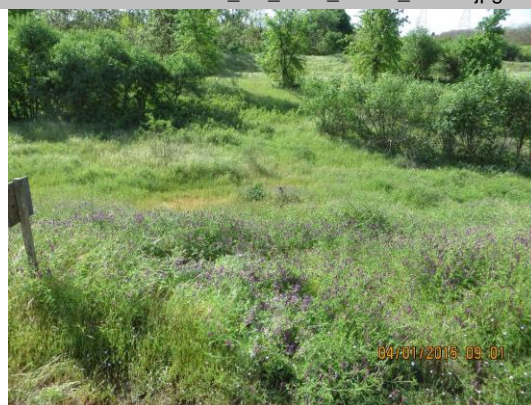
Photo 2 of 2 : UCIP\_SP\_2016\_44105\_73585.jpg

WS slope. pipe not visible.

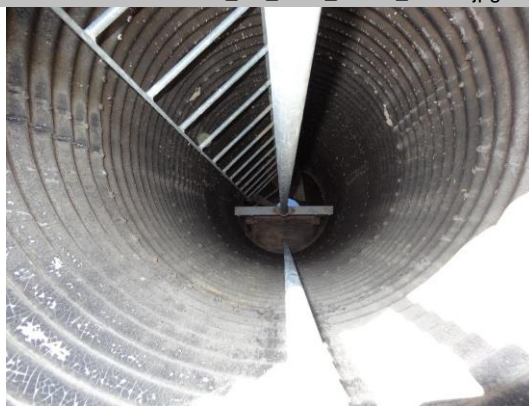
Photo 2 of 2 : UCIP\_SP\_2016\_41160\_19921.jpg

WS- inside CMP riser with air vent and slide gate.

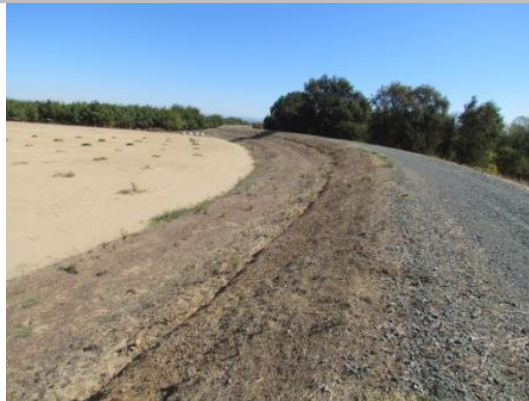
Photo 1 of 3 : SP\_2016\_RD0817\_13\_6\_20160307\_00002.jpg

This photo was taken from the crown of the levee back in facing east looking at the separation line in the soil on the land ward side between the clay and the sand. Fall 2013.

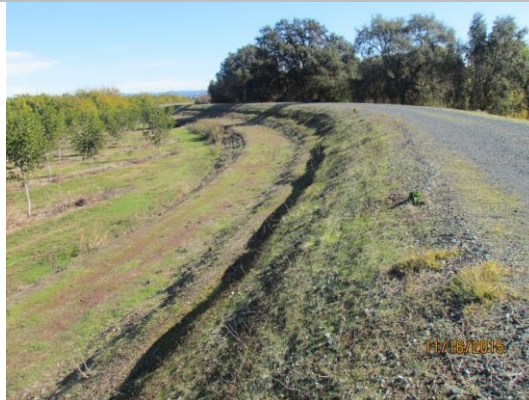
Photo 2 of 3 : SP\_2016\_RD0817\_13\_6\_20160307\_00003.jpg

View of the separation of soil on the landward side of the levee looking upstream. Fall 2015.

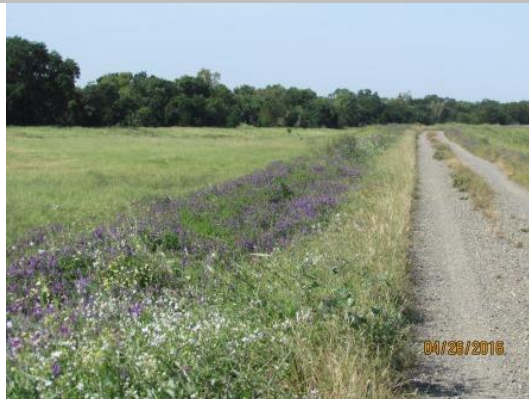
Photo 1 of 1 : SP\_2016\_RD0817\_14\_16\_20160427\_00025.jpg

View of typical vegetation on the landside looking upstream.

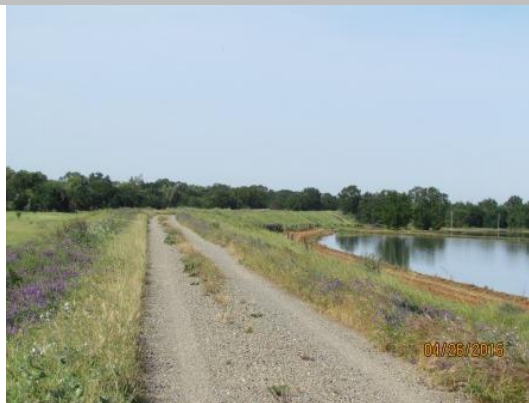
Photo 1 of 1 : SP\_2016\_RD0817\_14\_17\_20160427\_00026.jpg

LM Start	0.26	Rating **	M	Issue No.	17
LM End	1.27	Issue Type +	Ma	Location *	WS
Category	Earthen Levee			GPS Latitude/Longitude	
				Start	End
Item	Vegetation			38.987670 °	38.996877 °
				-121.506477 °	-121.491960 °
DWR ID	DWR_RD0817_03_s_2016_17				
Comment Code					
V1 : Control annual grass and weeds on the levee slopes and easements.					
Inspector Comment

View of typical vegetation on the waterside looking upstream.

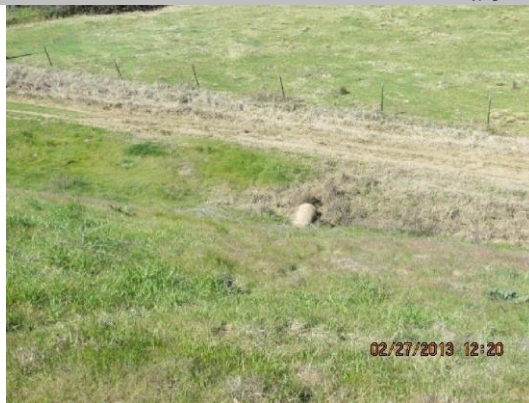
Photo 1 of 2 : UCIP\_SP\_2016\_46587\_54271.jpg

Pipe at LS toe

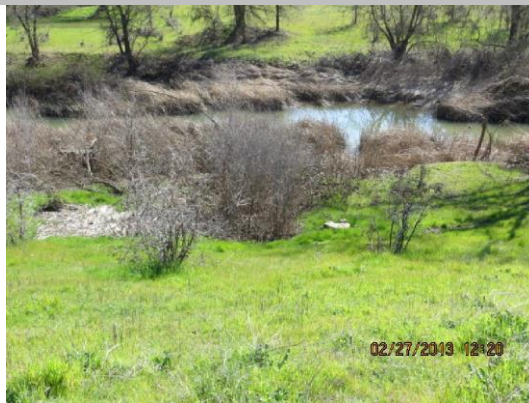
Photo 2 of 2 : UCIP\_SP\_2016\_46587\_54270.jpg

Outlet in brush at WS toe.

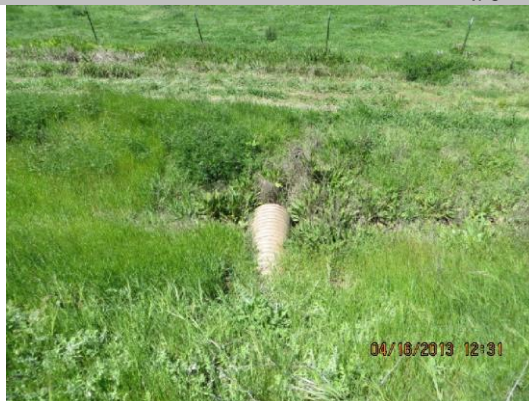
Photo 1 of 2 : UCIP\_SP\_2016\_42686\_19927.jpg

LS- overview of CM drainage pipe on toe of the levee.

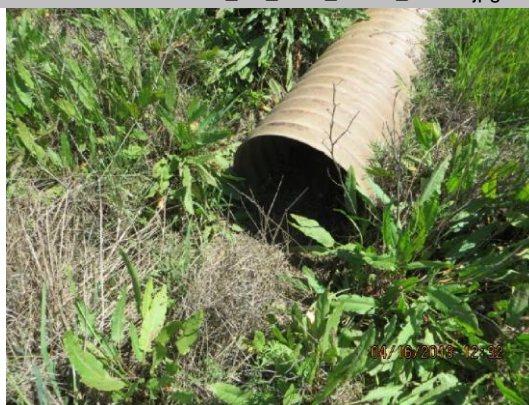
Photo 2 of 2 : UCIP\_SP\_2016\_42686\_19926.jpg

LS- CM drainage pipe on toe of the levee.

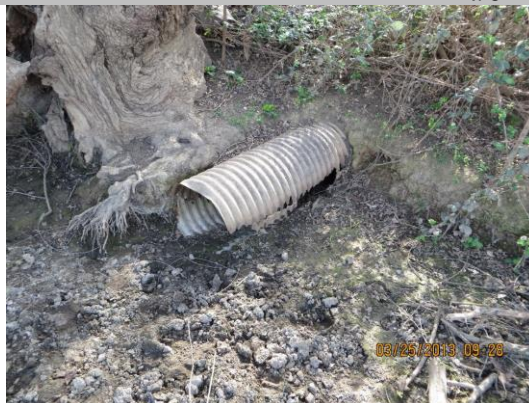
Photo 1 of 2 : UCIP\_SP\_2016\_46588\_53849.jpg

Pipe on LS toe corroded through.

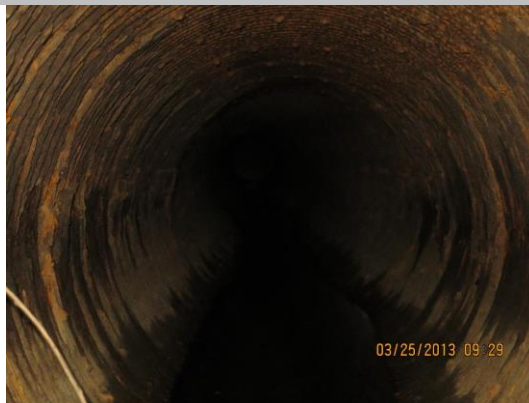
Photo 2 of 2 : UCIP\_SP\_2016\_46588\_53848.jpg

Pipe Heavily corroded throughout

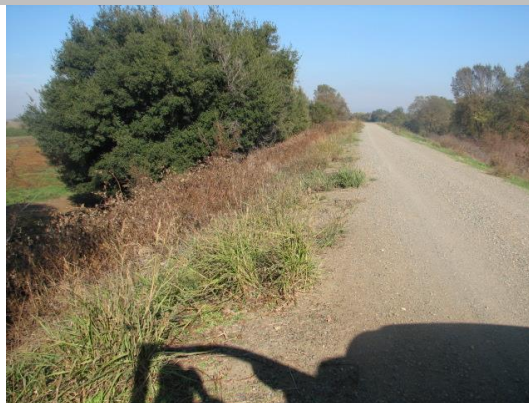
Photo 1 of 1 : SP\_2016\_RD0817\_14\_8\_20160307\_00001.jpg

Levee mile 0.54, the landside slope.

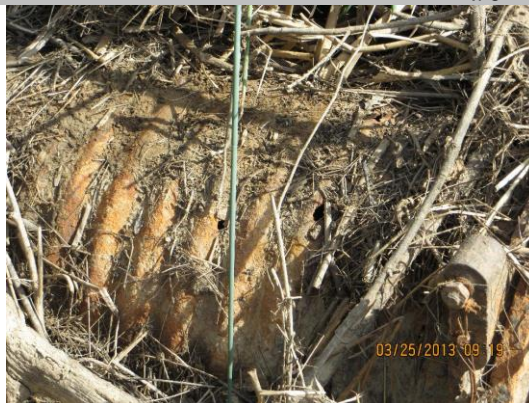
Photo 2 of 2 : UCIP\_SP\_2016\_46589\_53853.jpg

Holes in pipe at broken flapgate on WS toe.

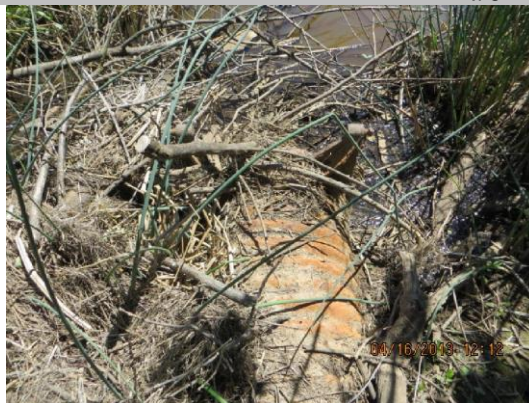
Photo 1 of 2 : UCIP\_SP\_2016\_41163\_19942.jpg

WS- CM pipe, flap gate and debris.

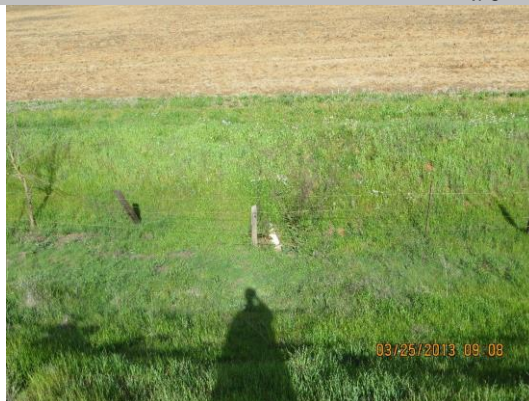
Photo 1 of 2 : UCIP\_SP\_2016\_46593\_53857.jpg

Pipe on LS toe with 8-inch PVC pipe sticking out.

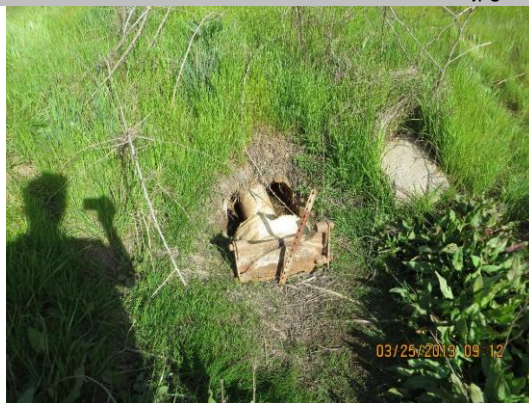
Photo 2 of 2 : UCIP\_SP\_2016\_46593\_53856.jpg

Pipe cut behind flap gate on WS toe with 8-inch PVC.

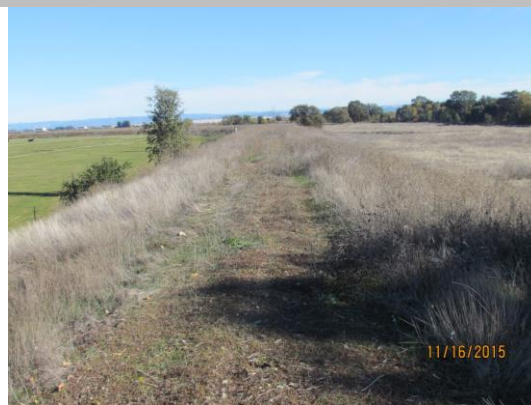
Photo 1 of 1 : SP\_2016\_RD0817\_14\_14\_20160307\_00002.jpg

View of the vegetation on the crown of the levee looking upstream. Fall 2015.

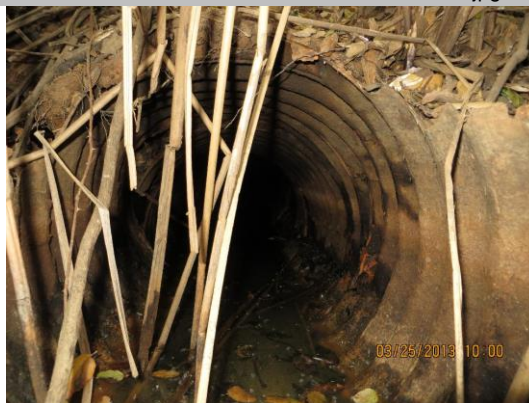
Photo 1 of 2 : UCIP\_SP\_2016\_46891\_53859.jpg

Pipe at inlet on LS toe.

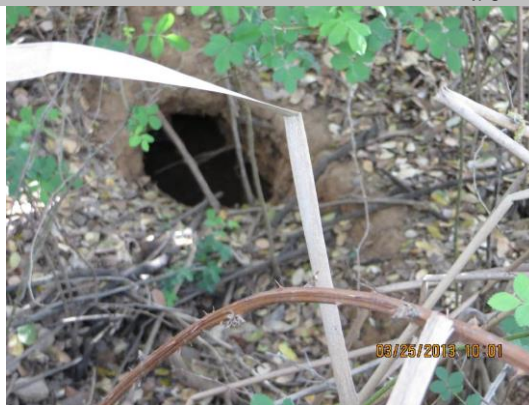
Photo 2 of 2 : UCIP\_SP\_2016\_46891\_53858.jpg

Sinkhole or animal burrow over pipe on LS toe.
